SUBJECT: Unannounced Clean Air Act Inspection of Bagcraft, Chicago, Illinois

Date of Inspection May 31, 2013

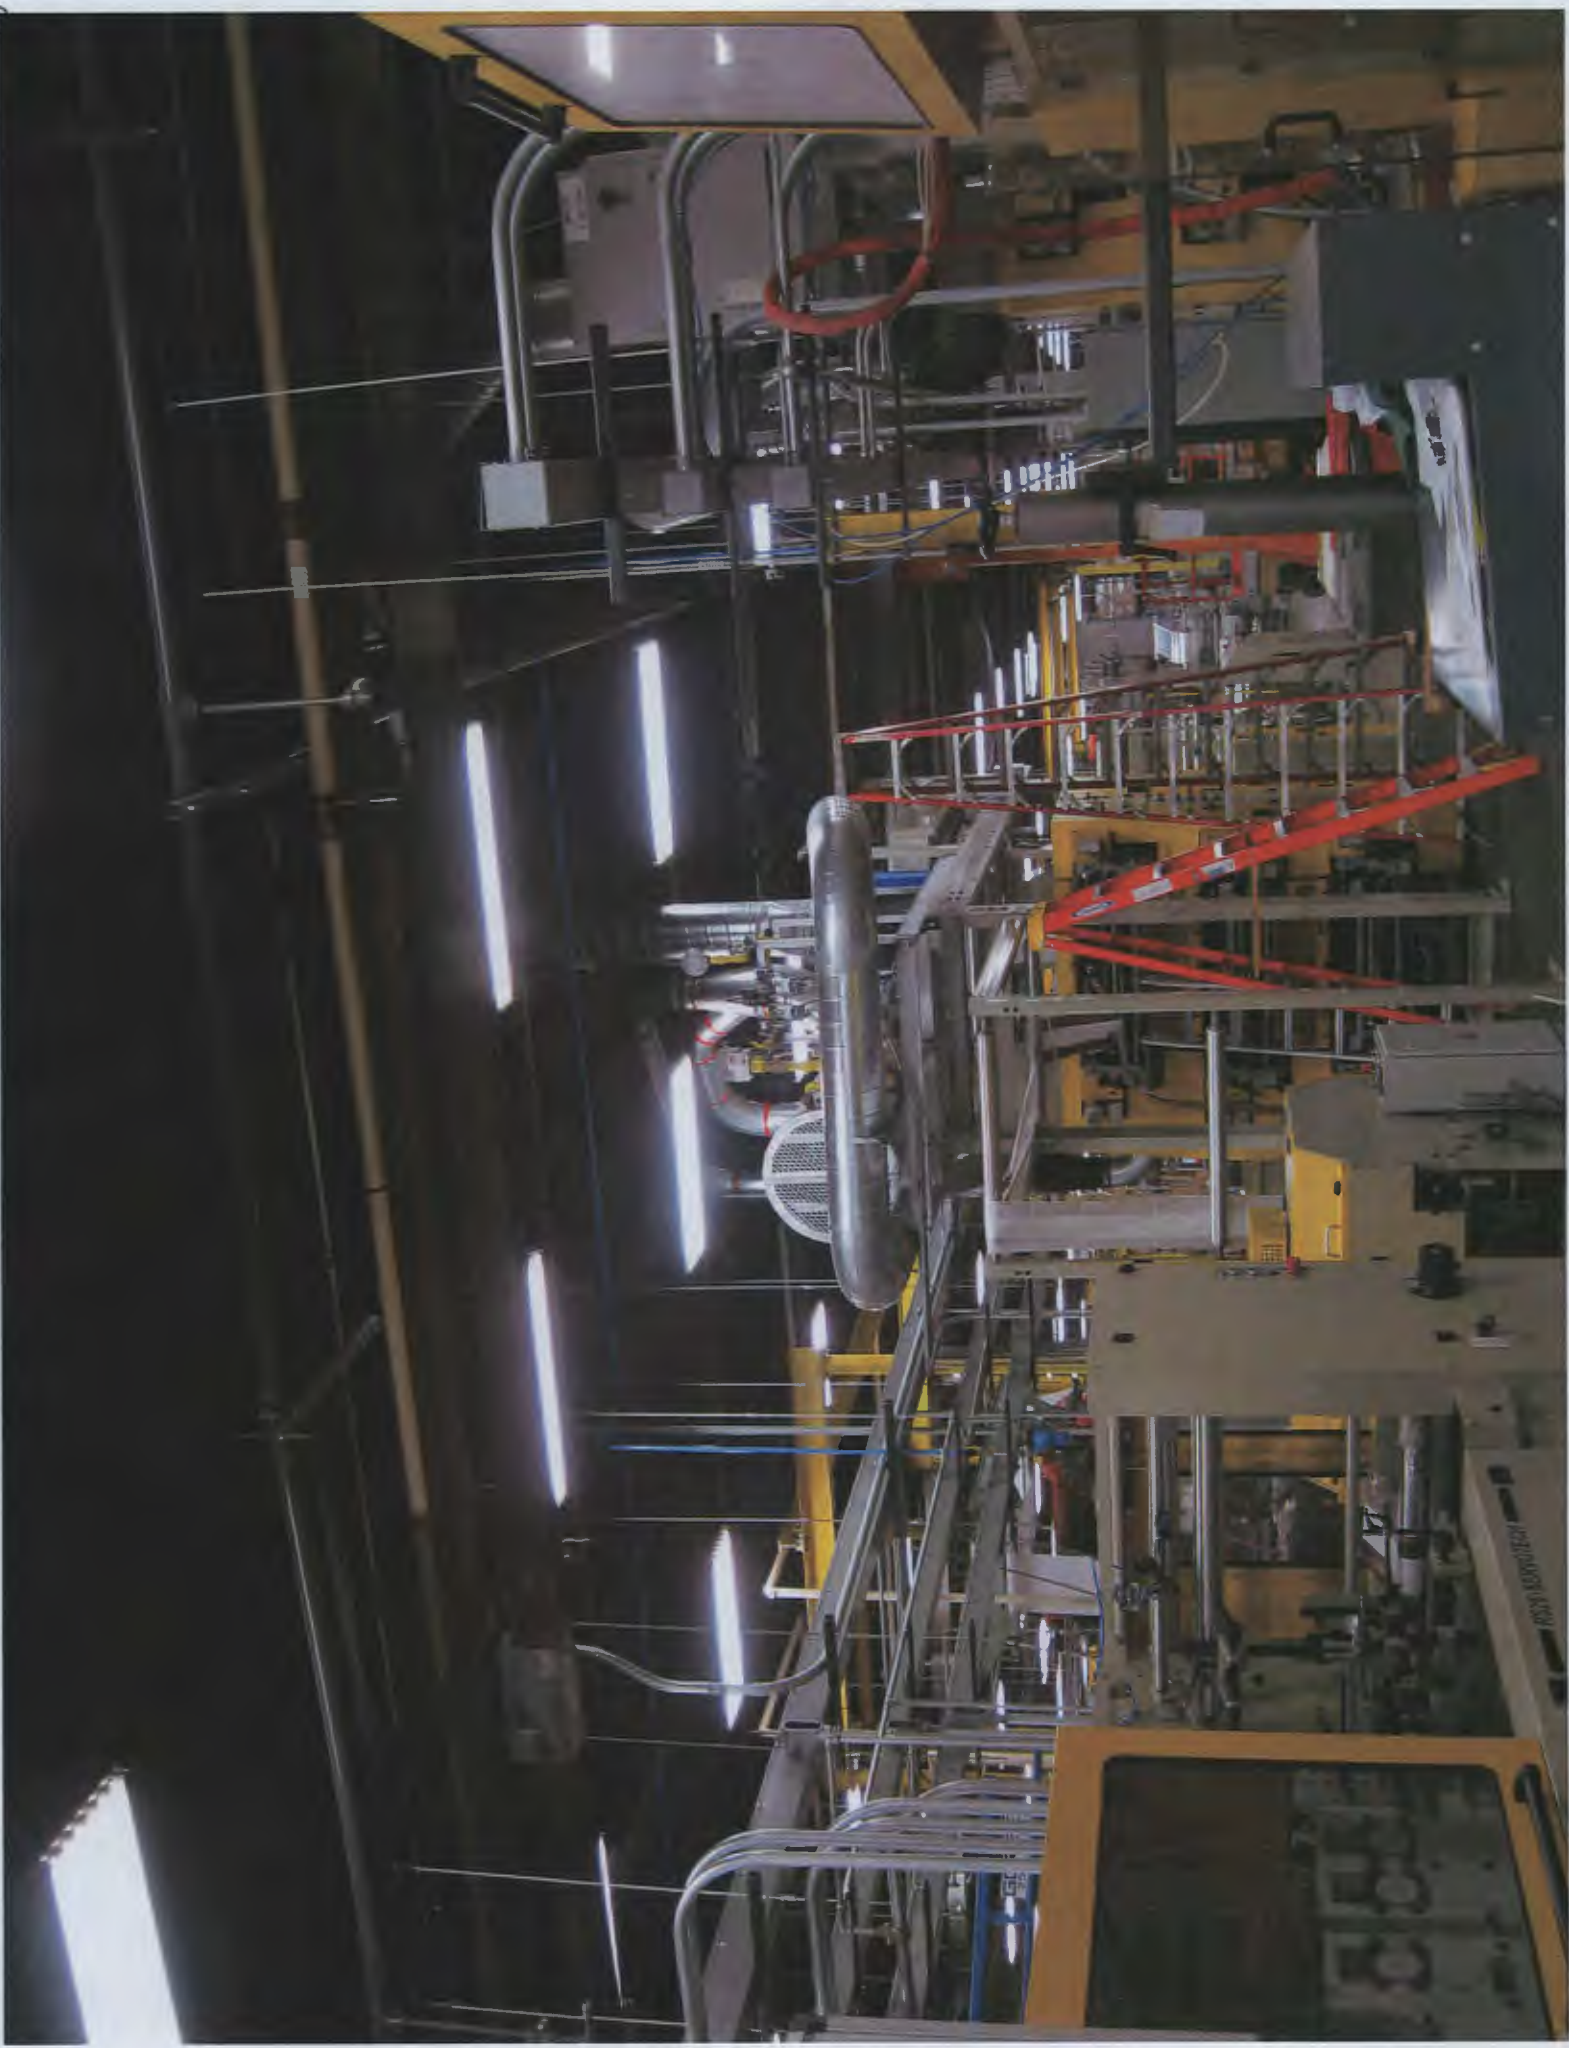
Next I looked at printer 173 (Photo 5) which is also relatively new and has a drier (Photo 6). The line was not operating today. Then I looked at Line 3, also relatively new, with no drier (Photo 7).

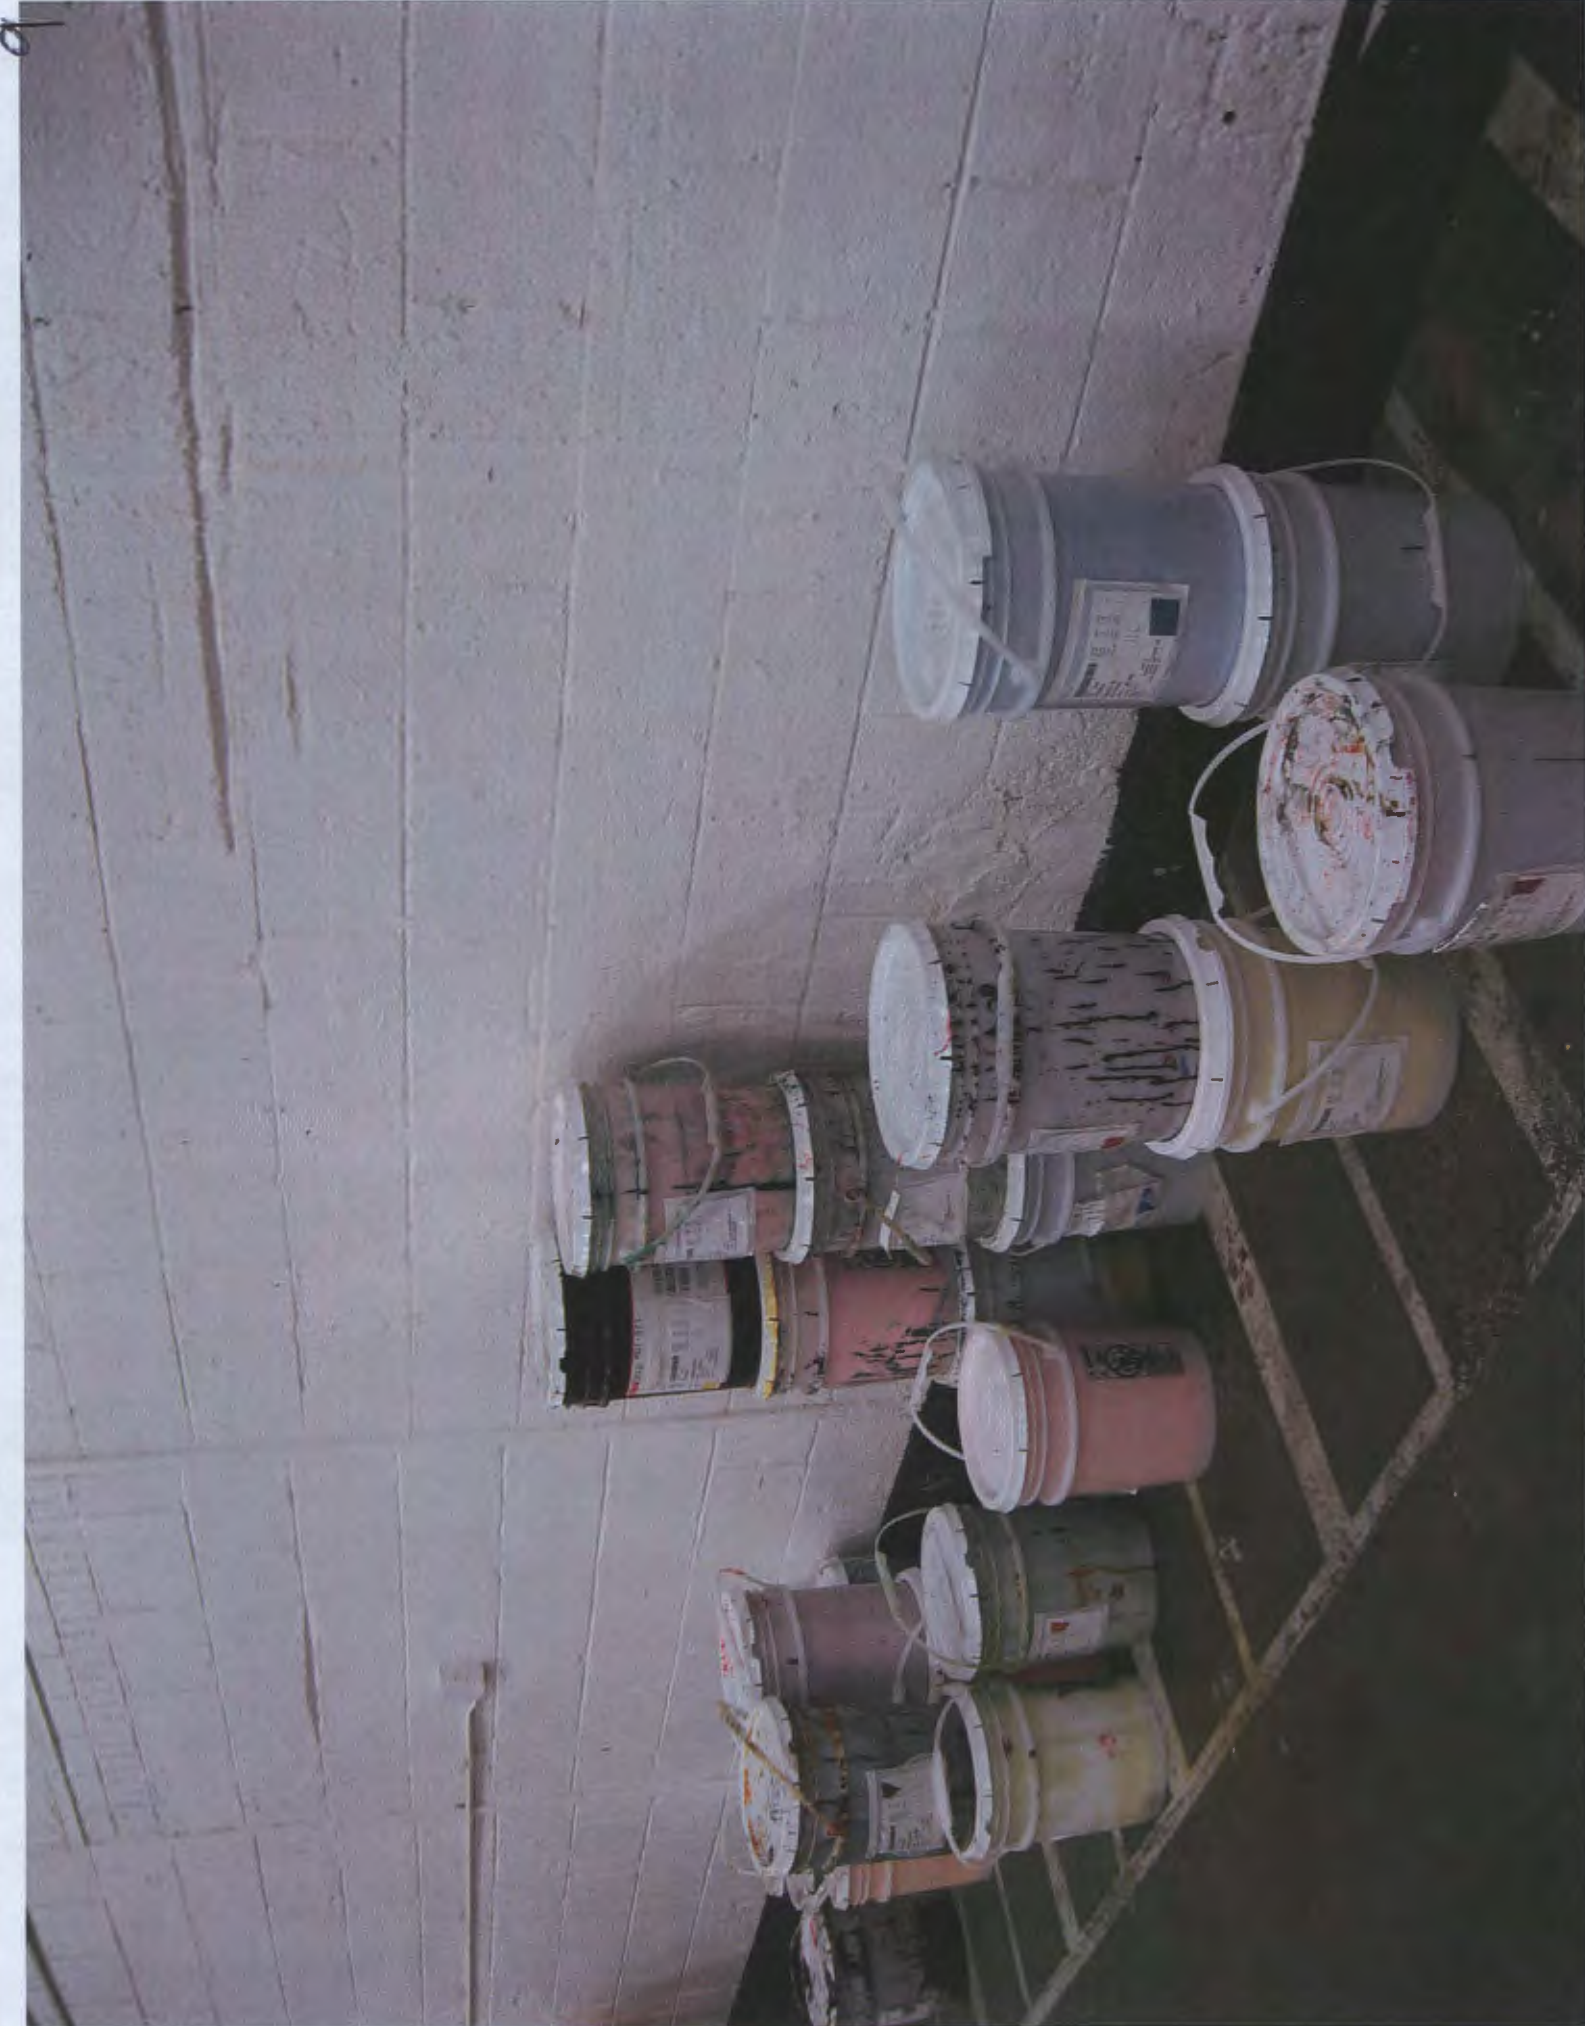
I took a photo of presses 170 and 171 together (Photo 8). Each has its own drier.

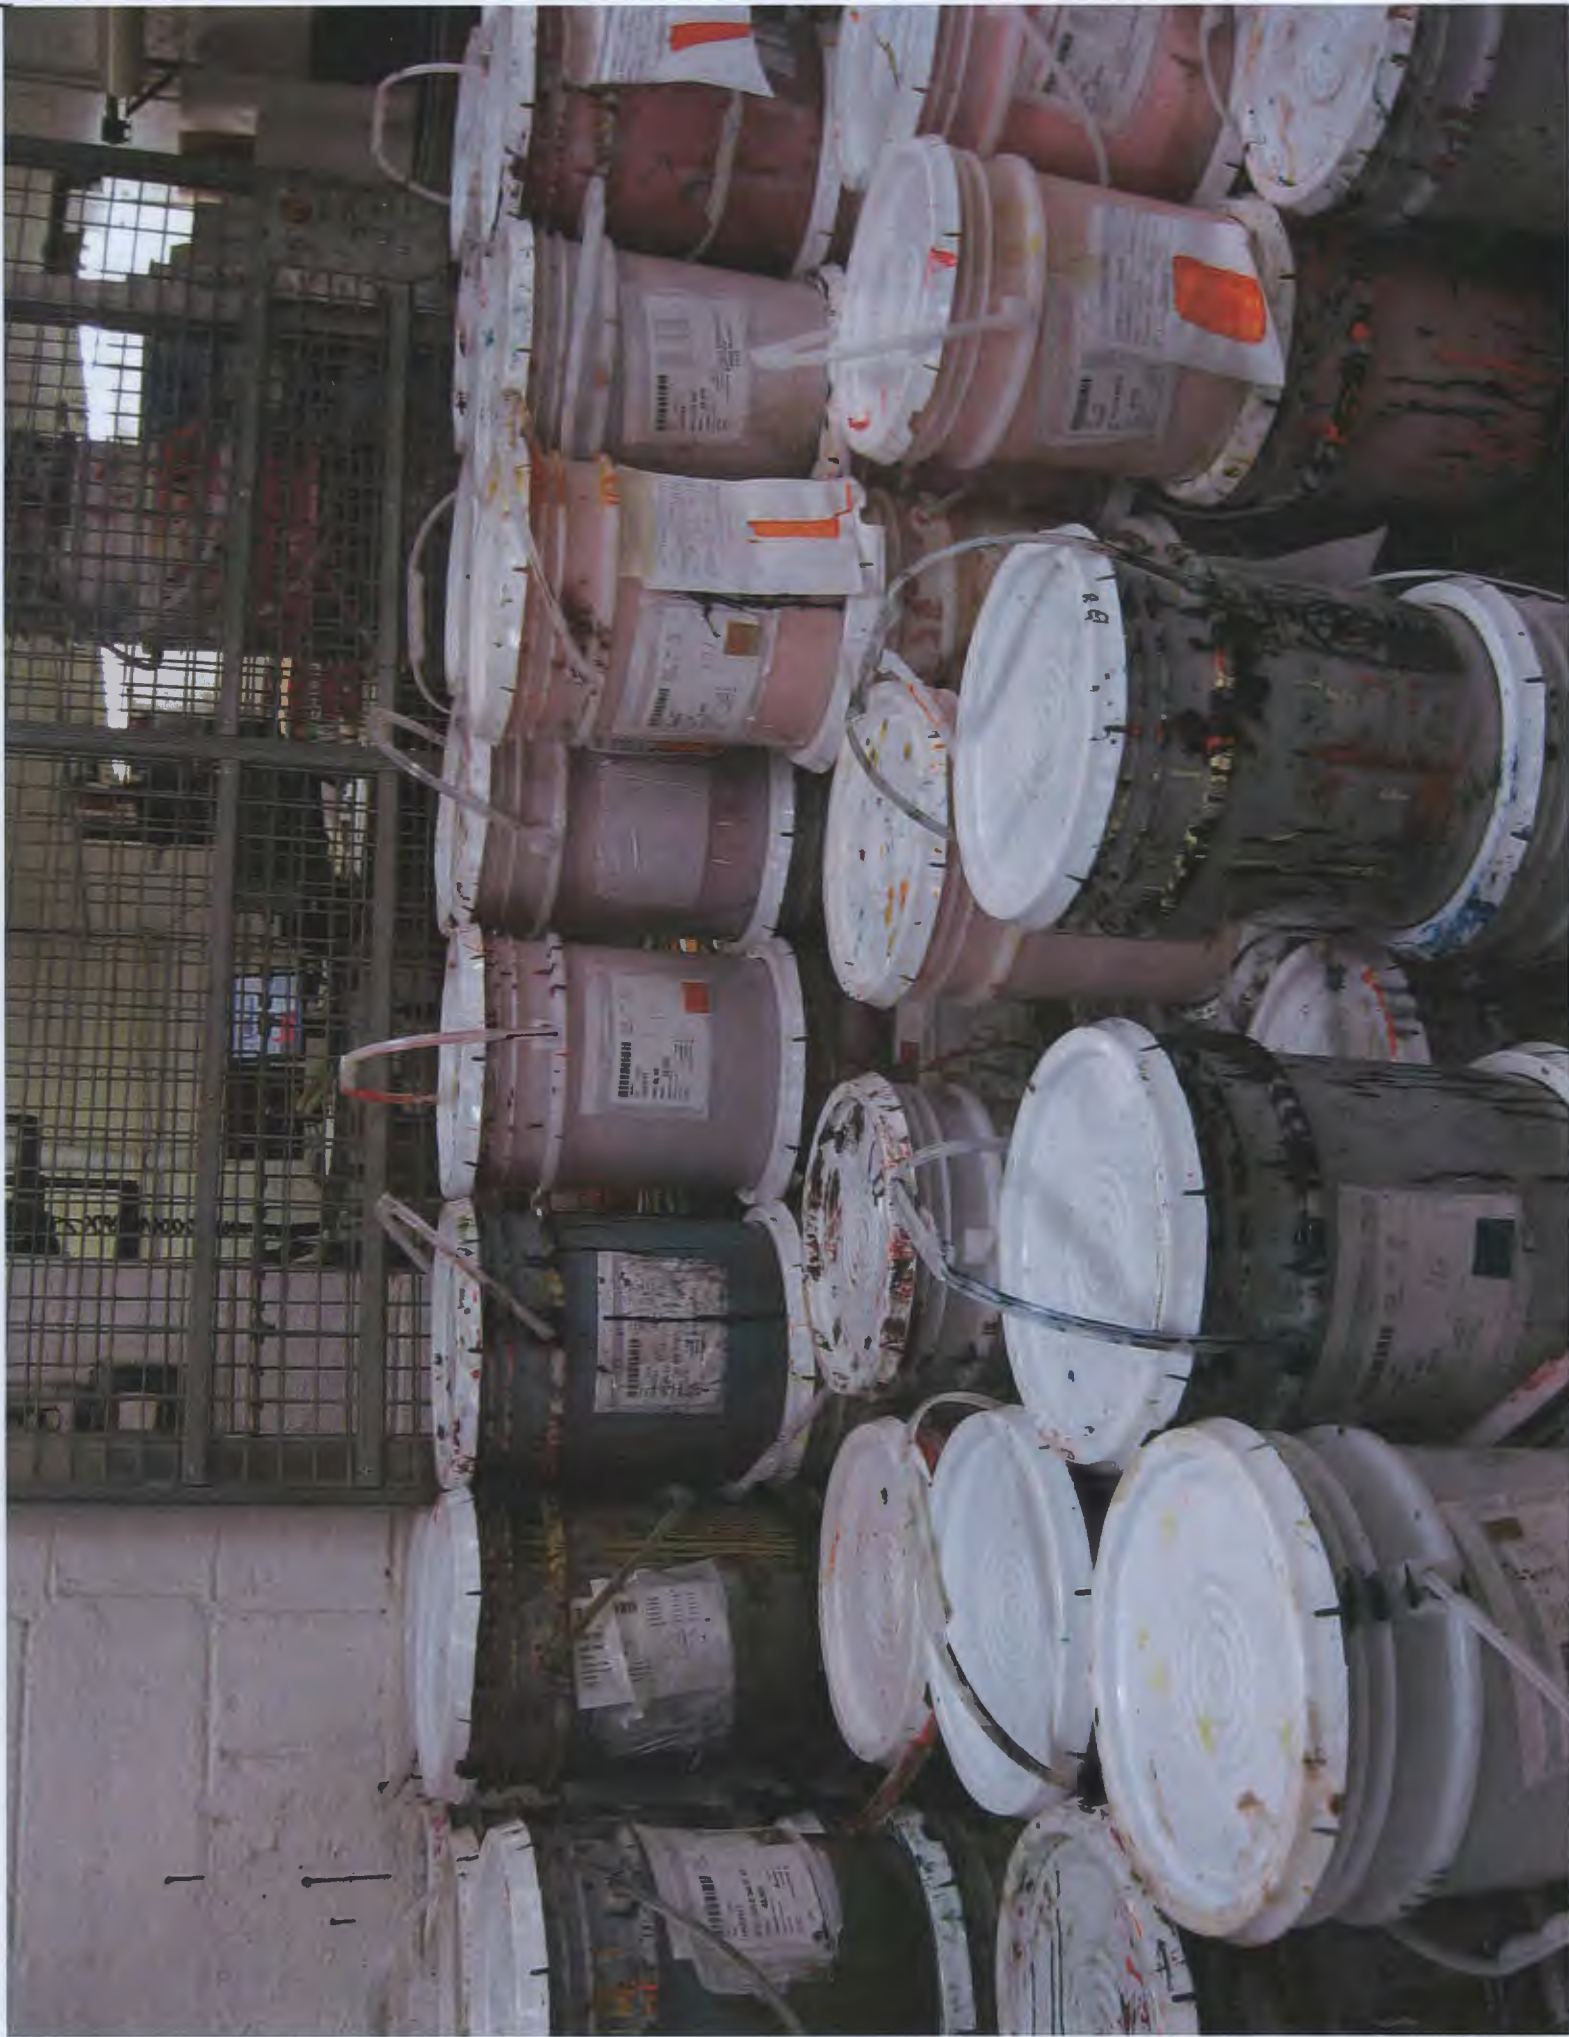
Next, while we were doing the walk through, I observed the pick up point for the inks and adhesives that are taken to the line (Photo 9). I took a photograph of one of the ink containers (Photo 10) and the extender (Photo 11). According to Mr. Leuth, the extender makes up the bulk of the ink. I also took a photograph of the return ink area where the operators return the ink (Photo 12). According to Mr. Leuth, return ink amounts are subtracted for recordkeeping purposes.

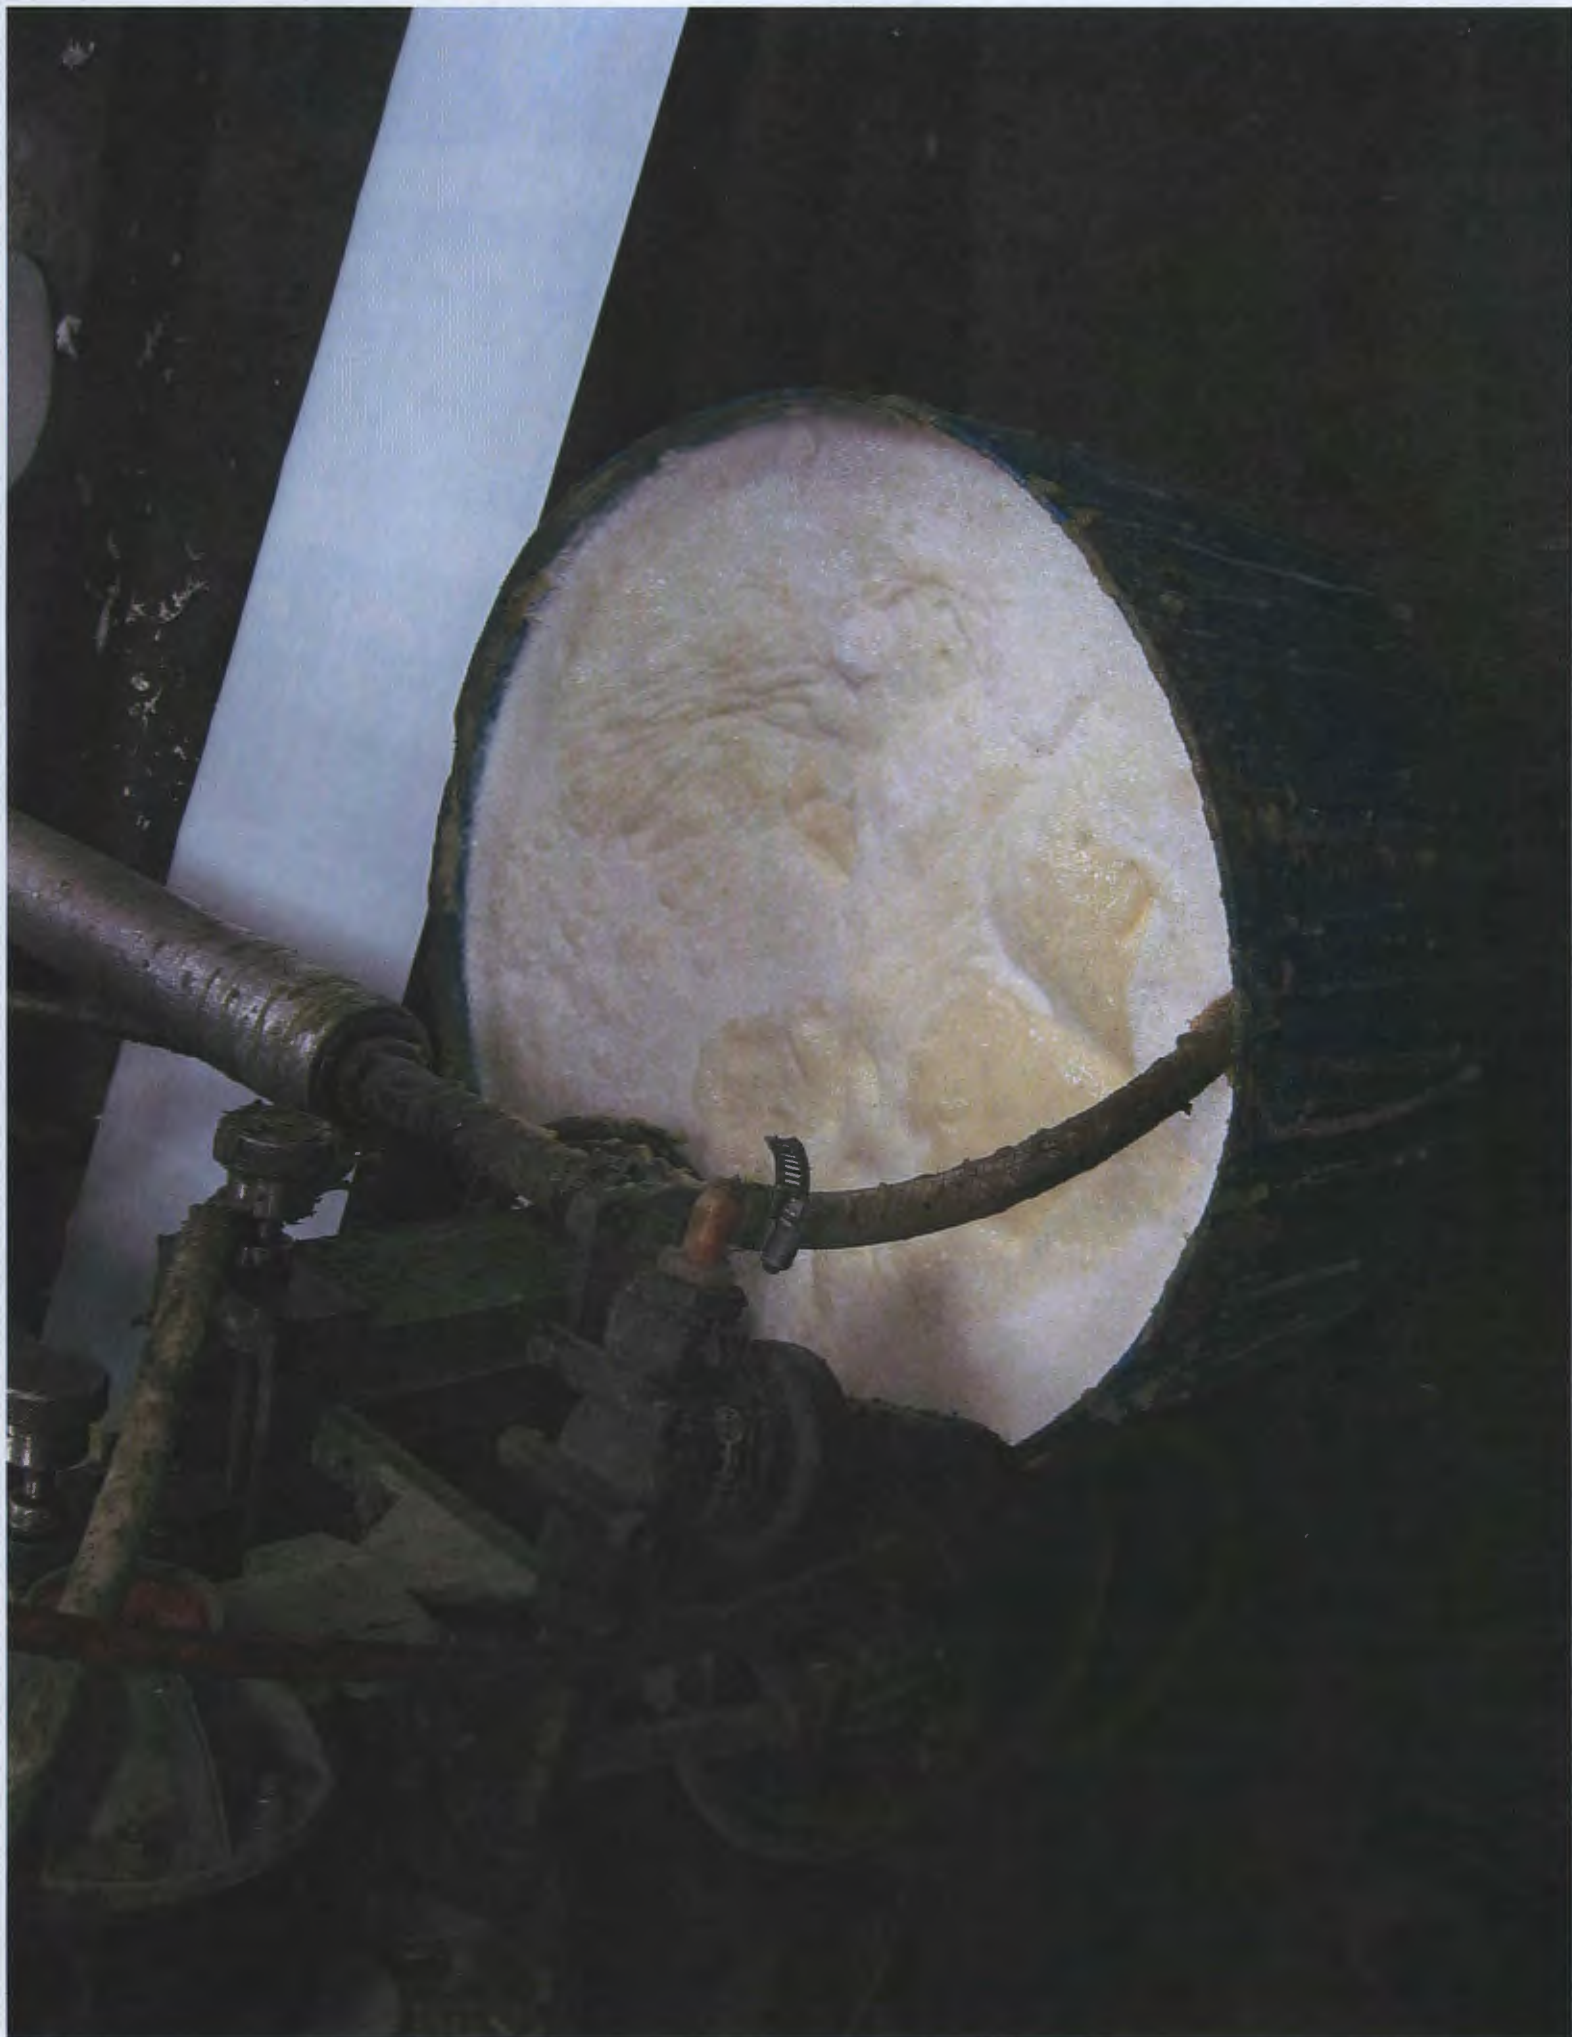
Next I looked at the ink (or mixing) room which has a computer with all the formulas (Photo 13). The computer tells them which line the various inks go to. This was done previously by the scheduling group. I took a picture of the mixing system (Photo 14).

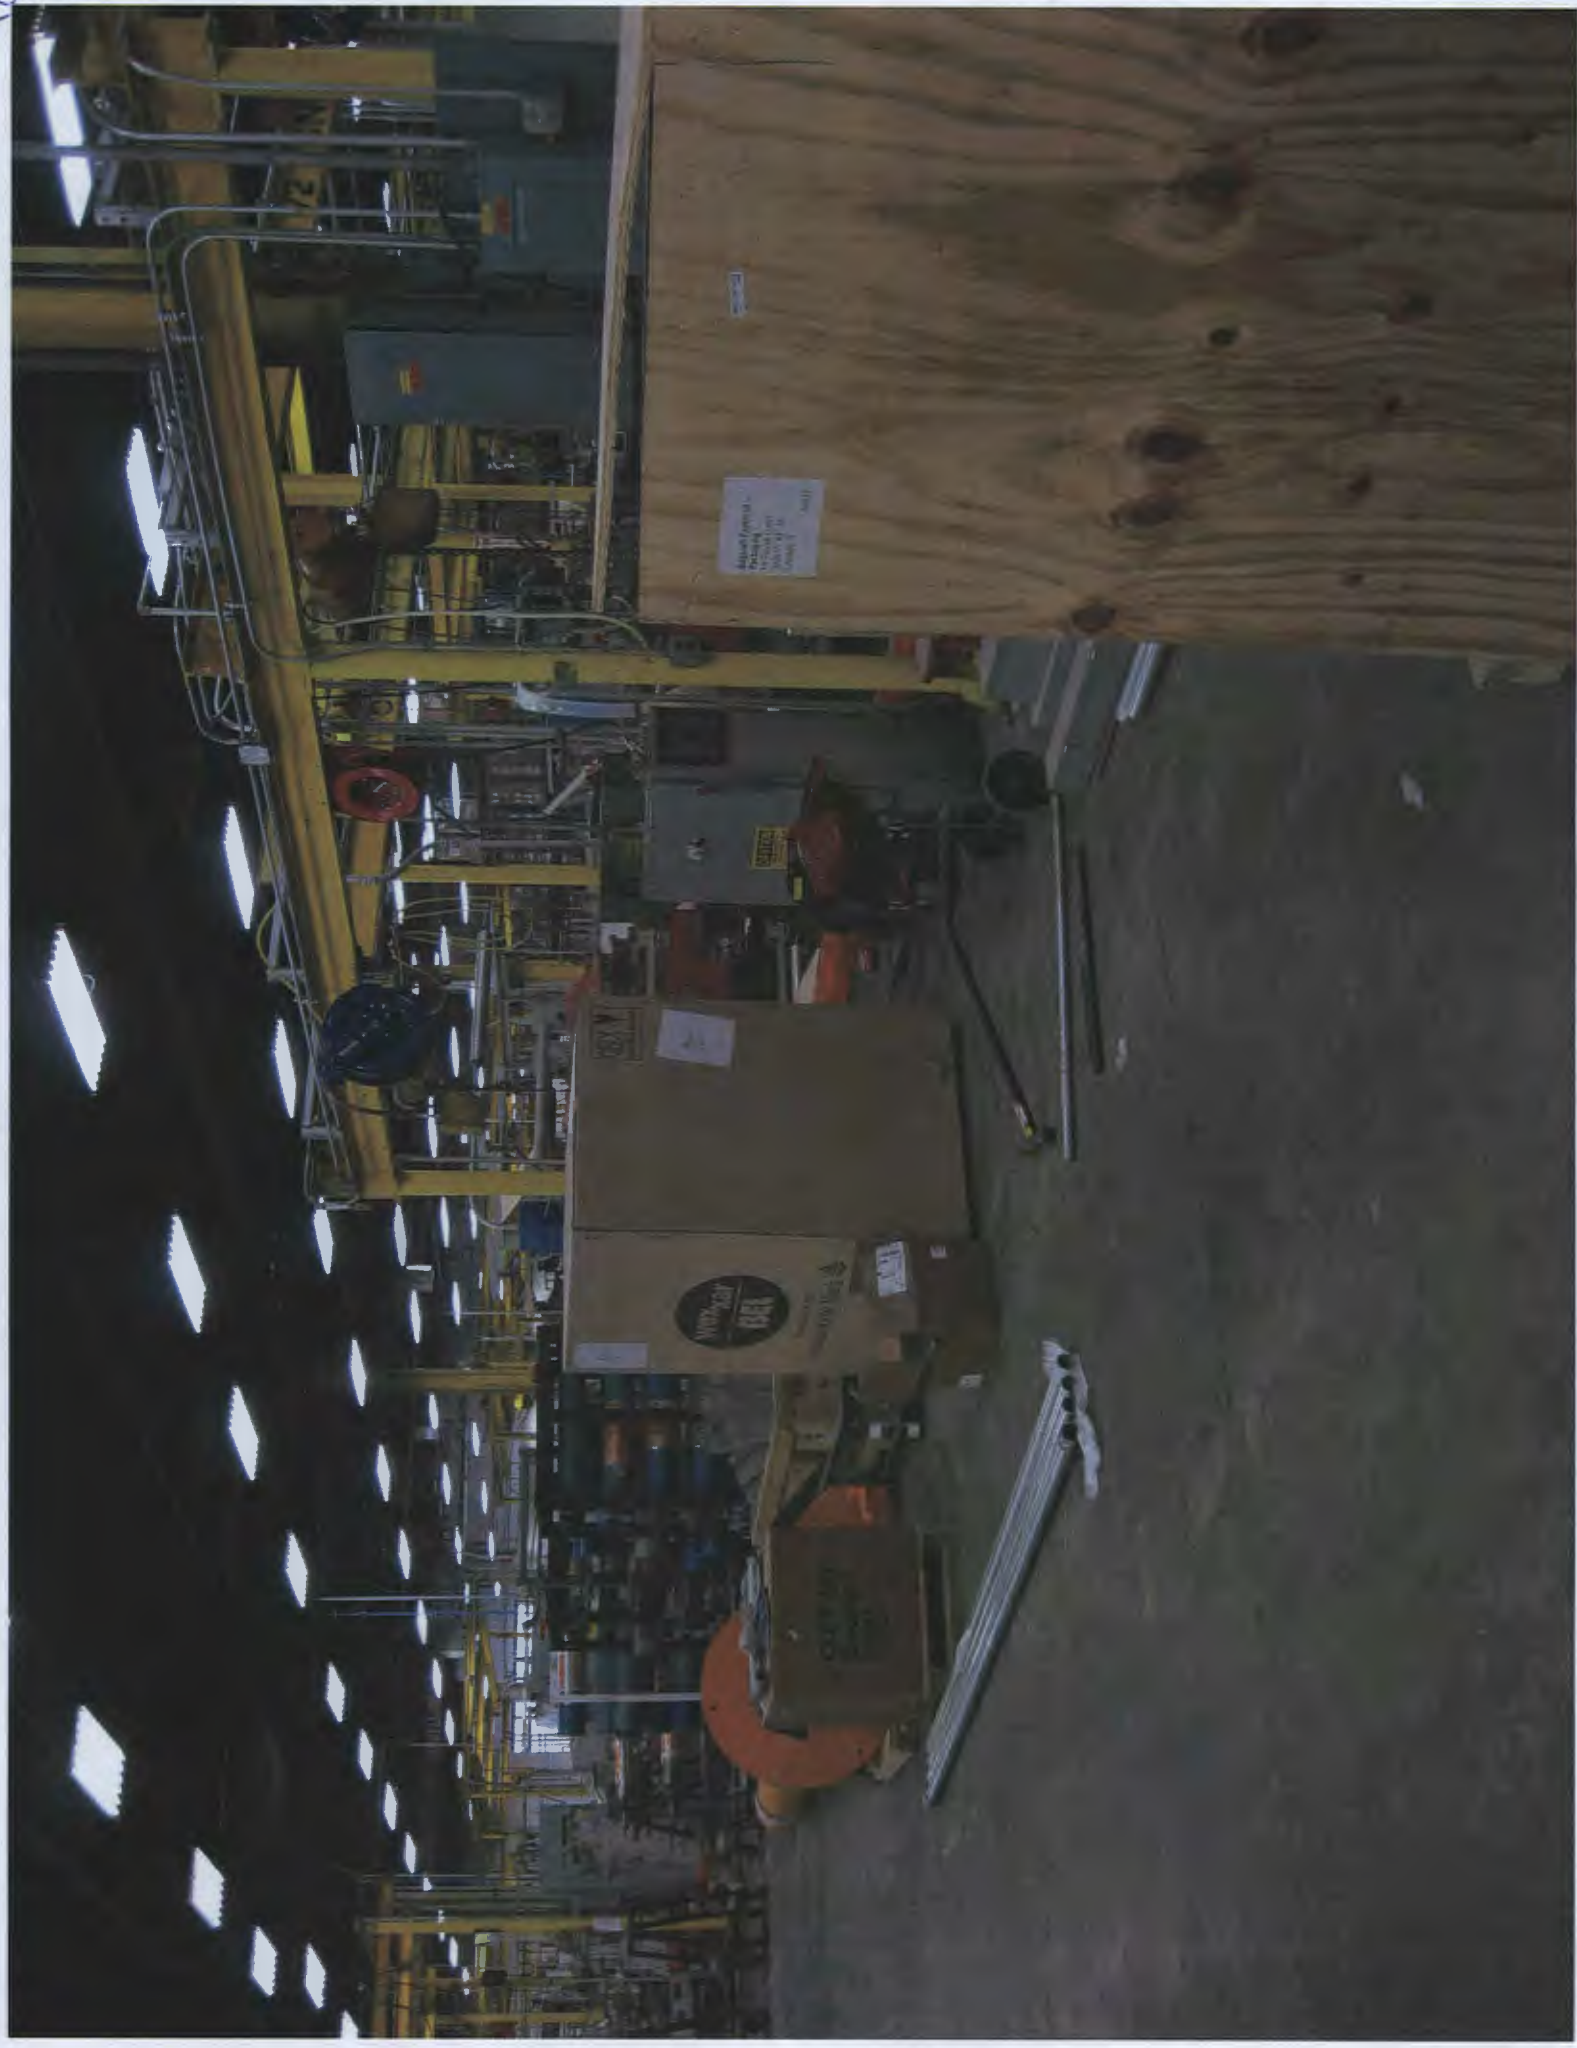
I next looked at the return ink room (Photo 15).

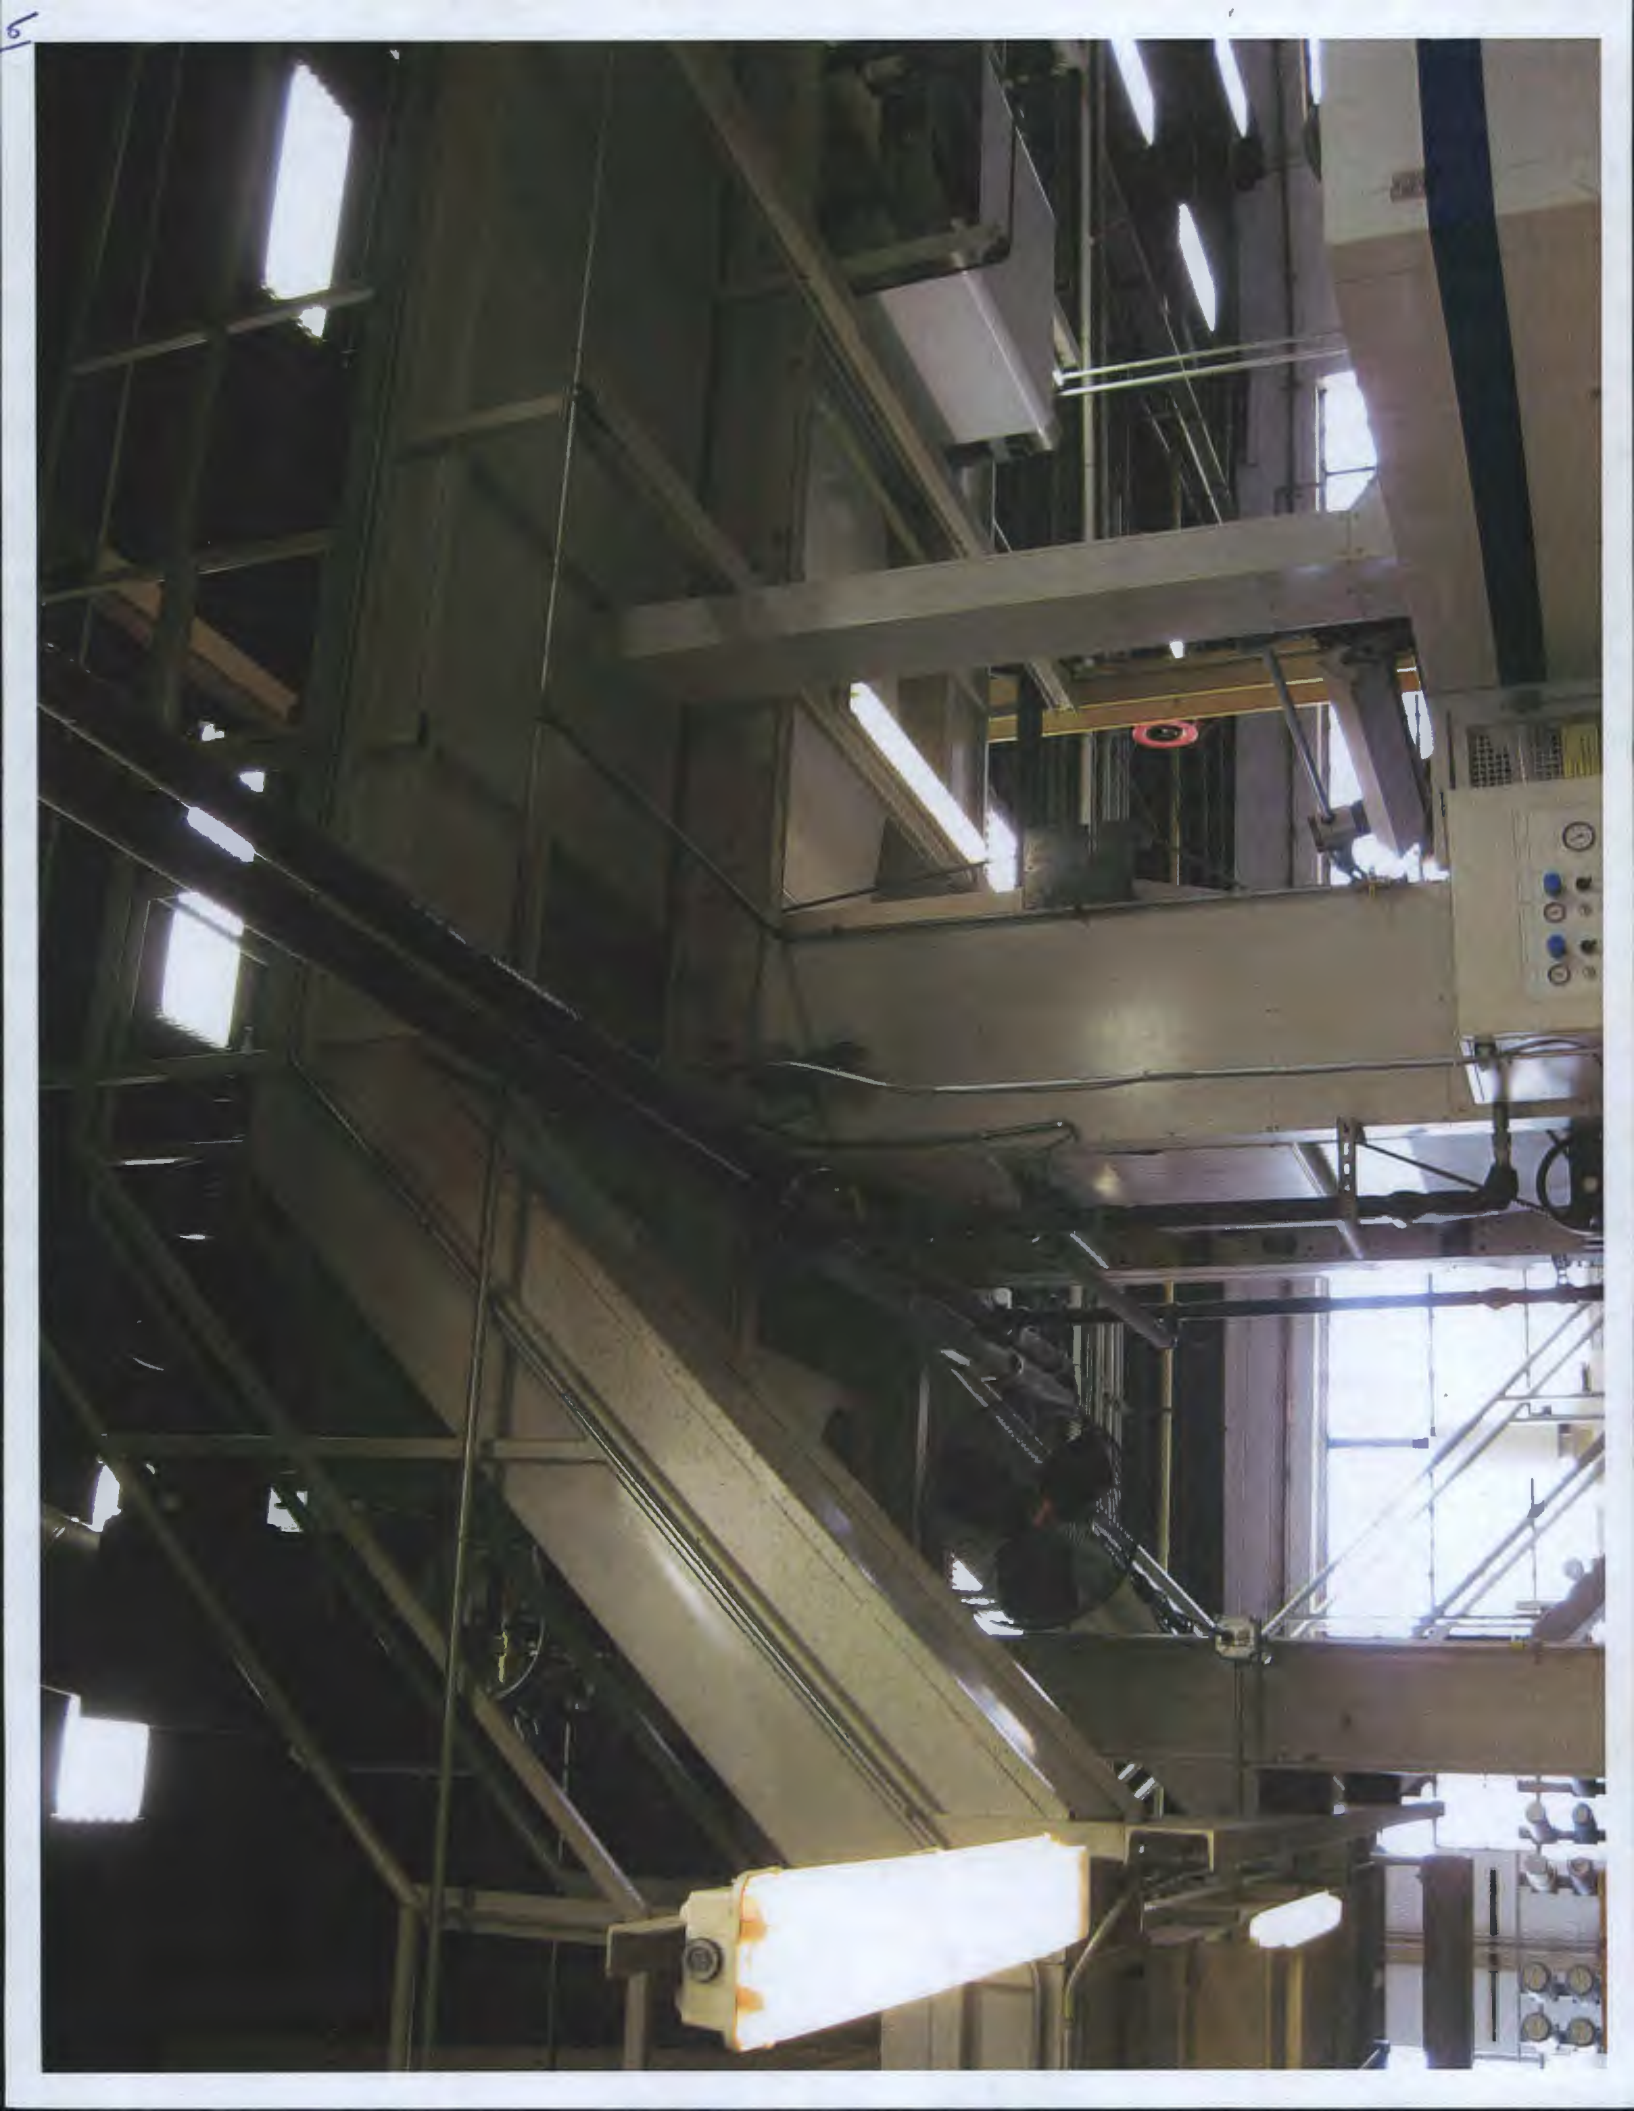
Next, I observed line 22 which one of the older lines. It was laminating the bags. I took a picture of the pot that holds the glue (Photo 16). Mr. Leuth stated that the bill of materials sets how much glue goes into the pots.
